Glady Run Stream Restoration and Preservation Project

Glady Run Stream Restoration Project

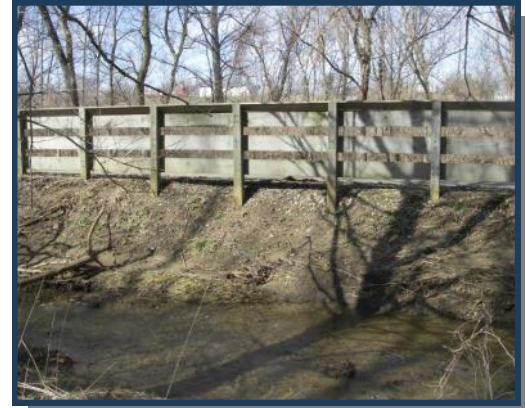
Pre-construction photo of eroding streambank at Glady Run, immediately adjacent to the Little Miami Scenic Trail bike path.

Coldwater assisted Greene County Parks & Trails (GCP&T) in the successful preparation of a grant application and implementation of a project to restore and protect approximately 3,500 linear feet of the Glady Run stream. This stream had been historically channelized and re-located along a historical railroad. Prior to construction of the project, the stream was suffering from severely eroding stream banks that were contributing substantial sediment and nutrient loads. The erosion was also threatening the adjacent Little Miami Scenic Trail / Ohio to Erie Trail that is heavily used for cycling and walking as well as a City of Xenia water main.

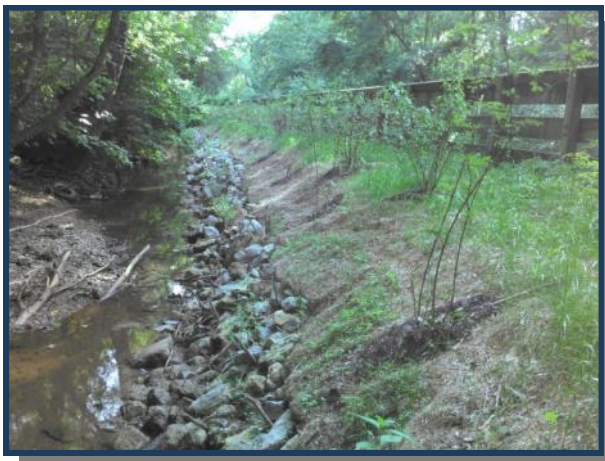
Post-construction view

The final design involved the construction of a stabilized bank slope featuring toe rock protection and native seeding/ plantings. The project was designed to restore and stabilize eroding bank sections while maintaining the conveyance capacity of the channel. Permits obtained by Coldwater for the project included a U.S. Army Corps of Engineers Nationwide Permit 27, a local floodplain development permit, and an Ohio EPA construction NPDES permit.
