Willow Creek Stream and Wetland Restoration

Lorain County Community Development Department

Funding provided by USEPA under the Great Lakes Restoration Initiative

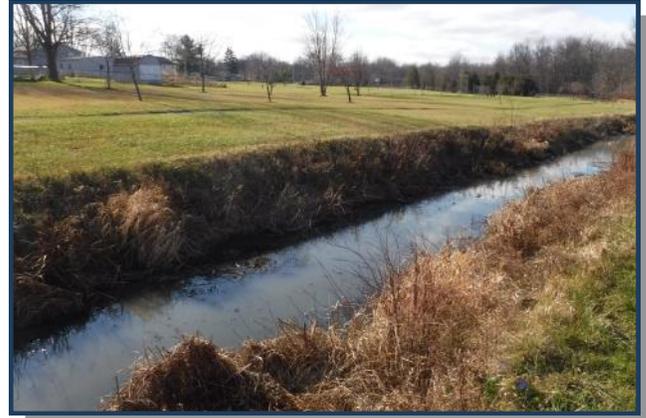
Pre-construction: Willow Creek had been channelized and deepened to the point that it lost all connection to the adjacent floodplain.

The restoration work is designed to improve stream and riparian habitat by installing in-stream riffle structures, constructing bankfull benches, and excavating an active floodplain that will allow for storage of flood flows and improvement to water quality through assimilation of sediment and nutrients during high flows when loading is most prevalent. A floodplain basin was excavated adjacent to the restored channel, with an outlet connecting it to Willow Creek. The project was designed so that the majority of the excavated floodplain will develop into wetlands that have active hydrological connection with the stream. Native plantings will restore functioning riparian and floodplain areas, and provide high quality habitat for aquatic and terrestrial wildlife.

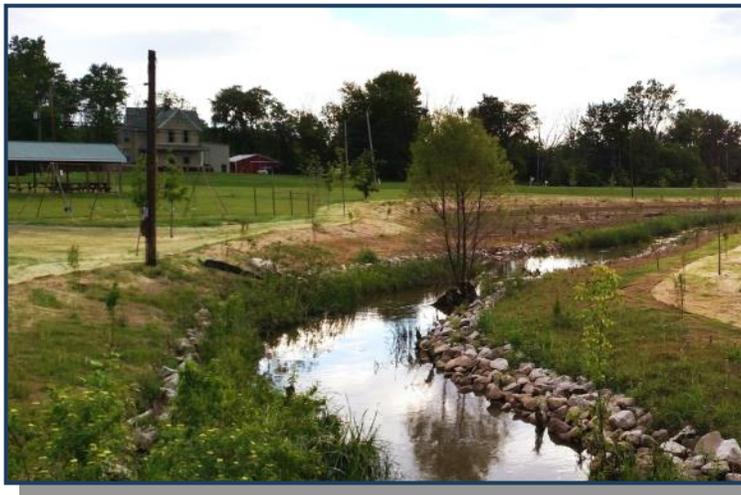
Restored Willow Creek channel and floodplain wetland basin, immediately after construction.

To stabilize Willow Creek, vertical and erosive banks were graded back and a rock toe was installed to secure the slope. The rock toe was densely planted with native live stakes to stabilize the bank and improve aquatic habitat and cover. In-stream features include two riffles installed within the channel. The submerged rock toe and riffles provide habitat for fish, macro-invertebrates, and other aquatic organisms.
